# British Fortifications in Zululand 1879

Ian Knight • Illustrated by Adam Hook

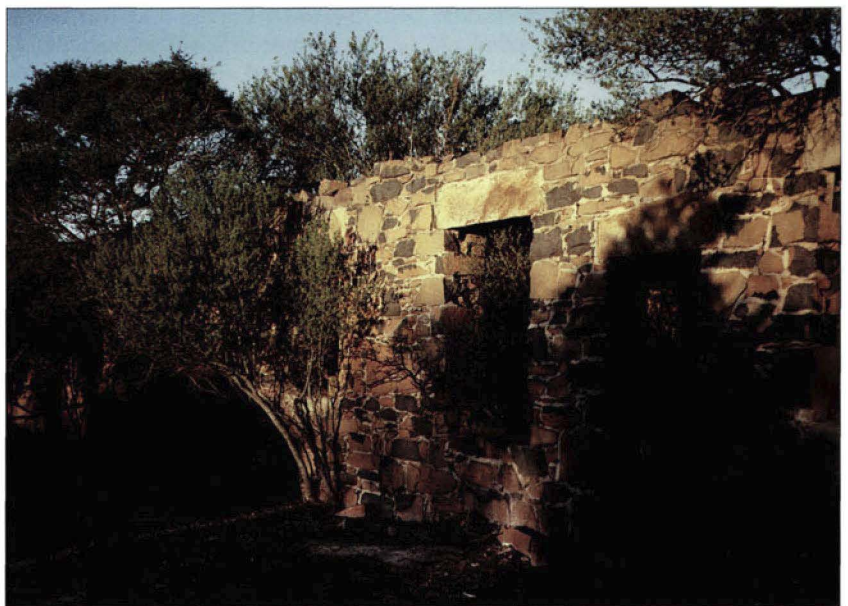
The interior of Fort Pine today – the most impressive border post along the Mzinyathi River, intended as a barracks for the Natal Mounted Police. The outlying walls and interior barracks – shown here – were all built from local stone.

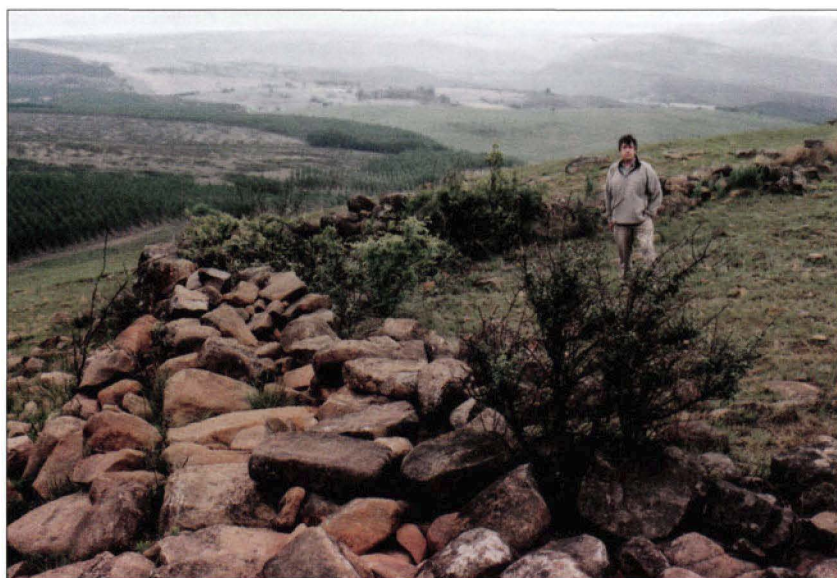
The author at Wolf Trap Fort, a small rectangular stone redoubt with a projecting bastion at the corner. It was built on high ground overlooking the Thukela River upstream from Middle Drift by the Ixopo Native Contingent, probably in May 1879.

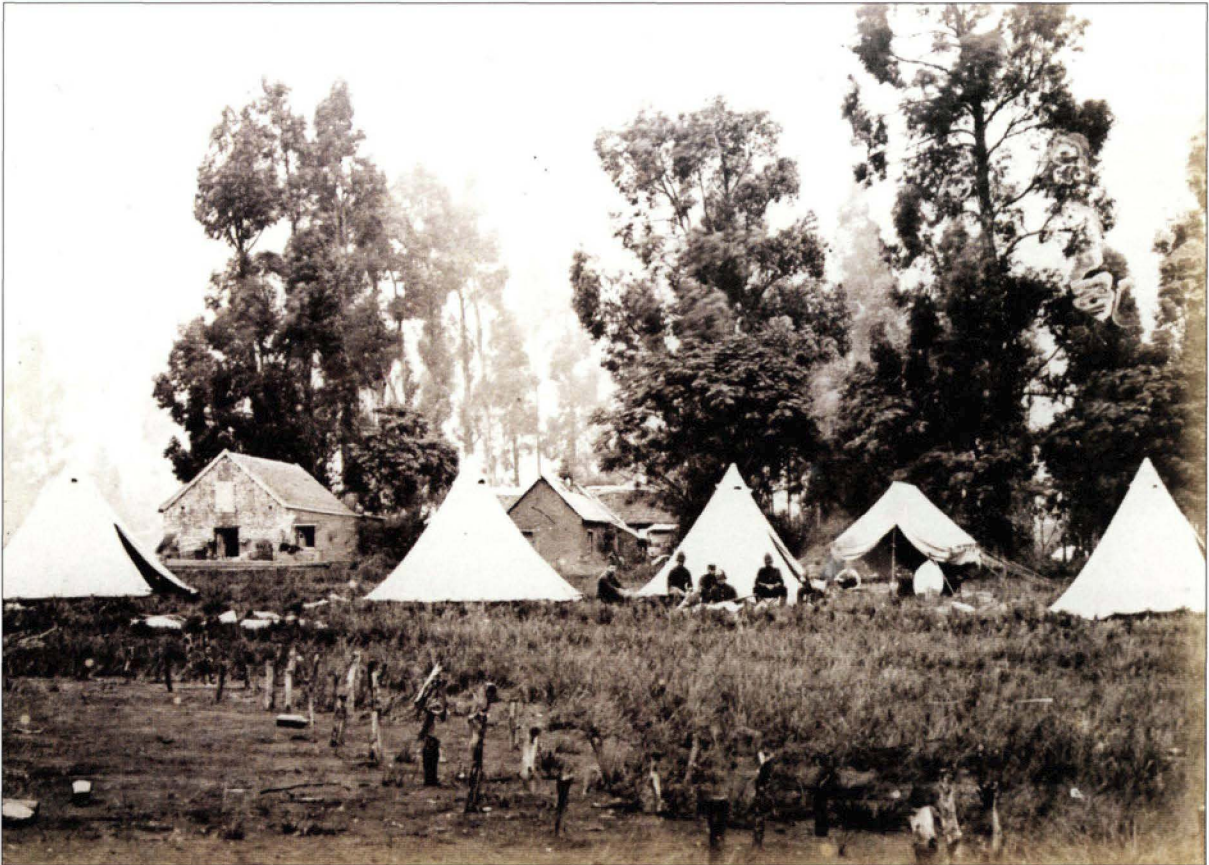
Part of the military camp outside the fortifications at Greytown. The picture is probably taken from between the trench and the wire entanglements; note the cleared glacis, the stakes between which the wire was stretched and the rather half-hearted attempt to litter the approaches with broken glass – several intact bottles are visible on the left.

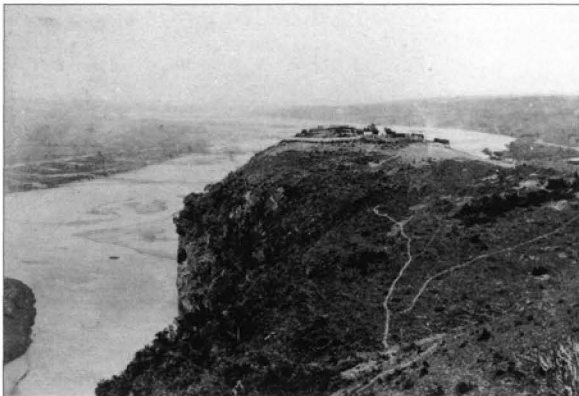
**BOTTOM LEFT** Fort Pearson, built in December 1878 on a knoll overlooking the Lower Thukela Drift into Zululand – which lies on the left of the photo.

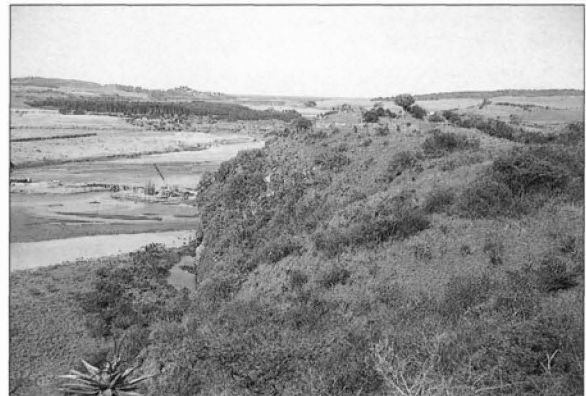
**BOTTOM RIGHT** The same view of Fort Pearson in the 1990s suggests the commanding geographical features of the position. The trenches are still clearly visible; a motorway bridge was then under construction, spanning the Thukela where a pont had once ferried Pearson's column across the Thukela.

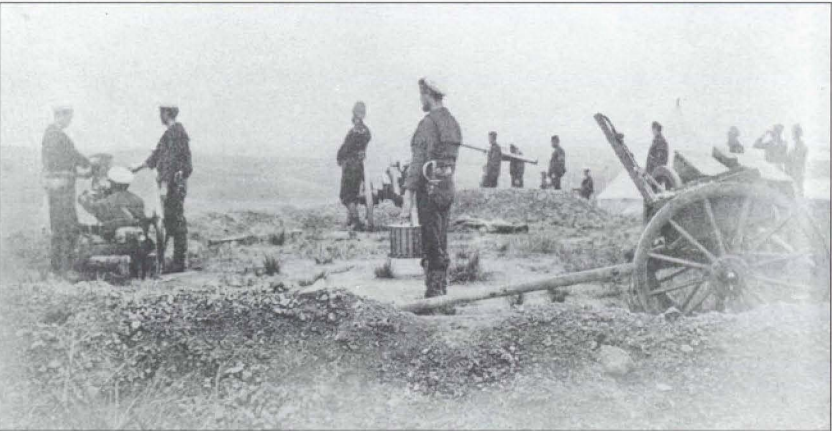
Sailors from HMS *Tenedos* man a Gatling gun (left), 7-pdr gun (right) and rocket trough (centre distance) in the small redoubt on the very top of Fort Pearson in January 1879.

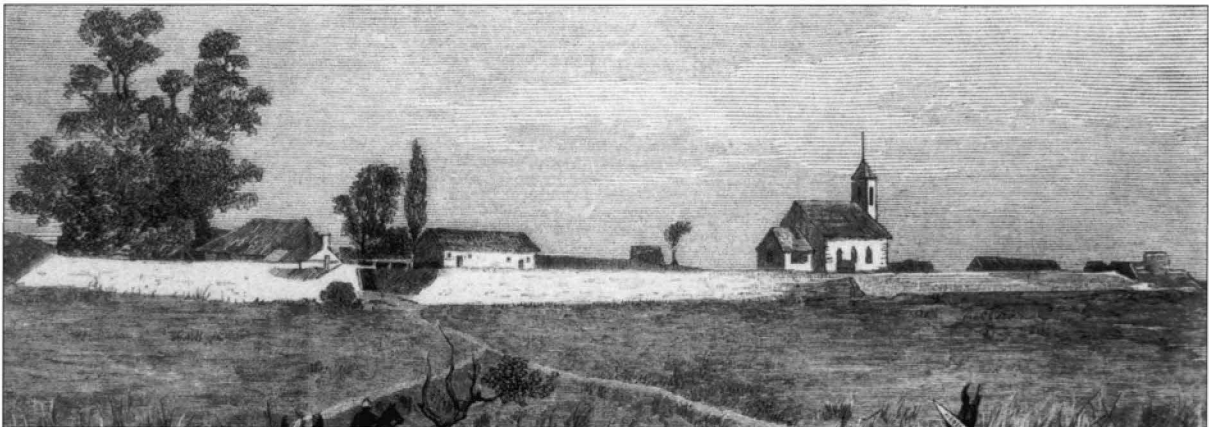
An overview of the fort at Eshowe, sketched at the end of the war, after it had been abandoned. The church is on the right – note the main entrance, left, and the trees that were left standing within the perimeter.

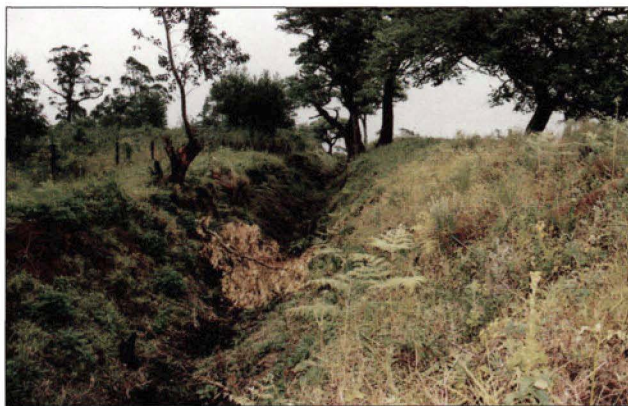
A view along the northern face of the fort today, showing Wynne's enduring legacy. Trench on the left; inner rampart right.

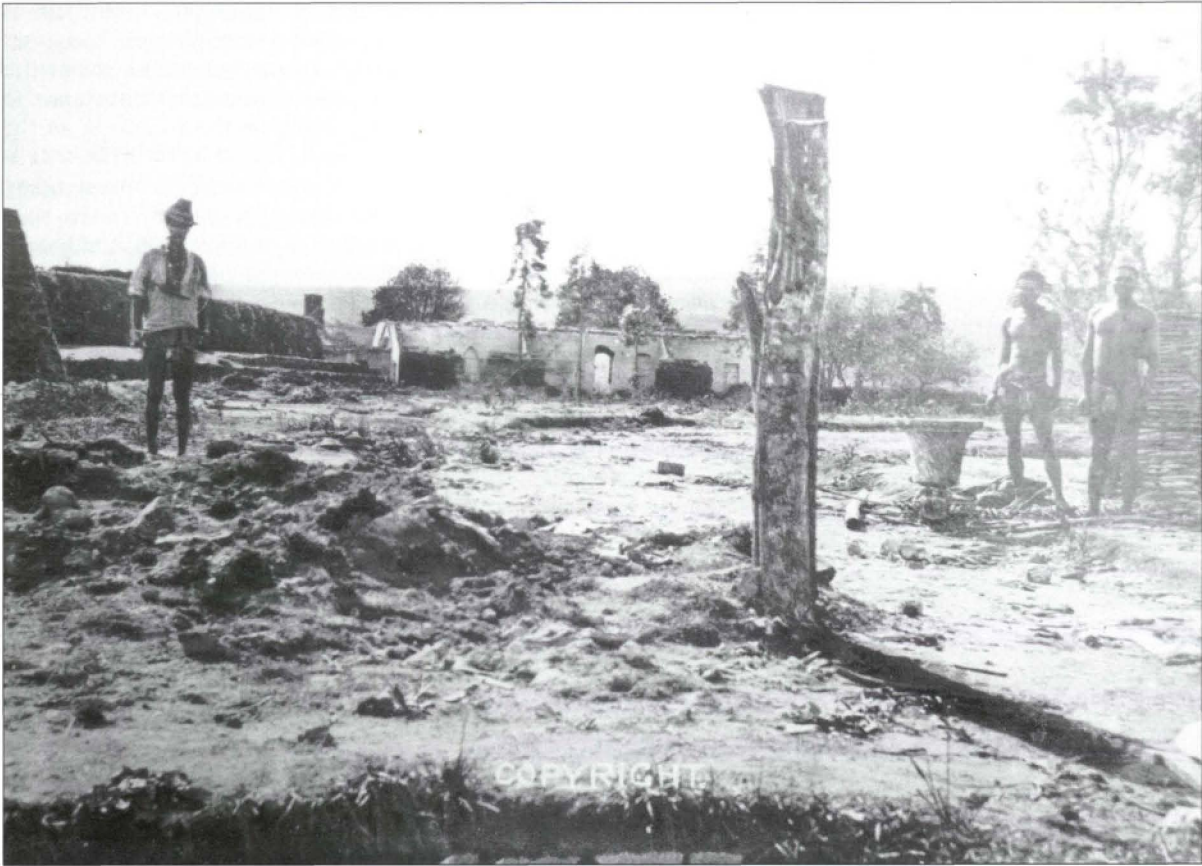
The interior of the fort at Eshowe, photographed c. June 1879, after its abandonment. Note the height of the ramparts, left, the ground churned up when the long-emplaced wagons were removed, the ruined buildings and the up-turned mission bell (right).

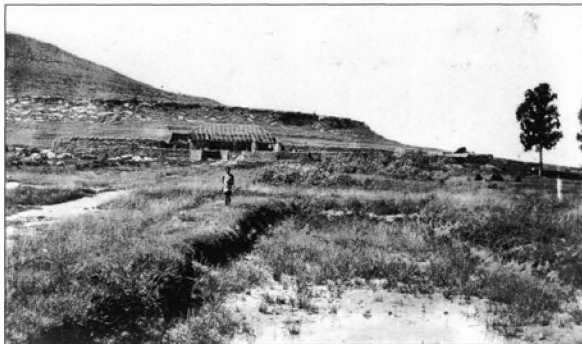
TOP LEFT The site of Rorke's Drift, photographed at the end of the war. In the centre is the old storehouse, surrounded here by the stout stone walls of Fort Bromhead. Behind is the terrace of Shiyane hill, occupied by Zulu musketeers during the battle.

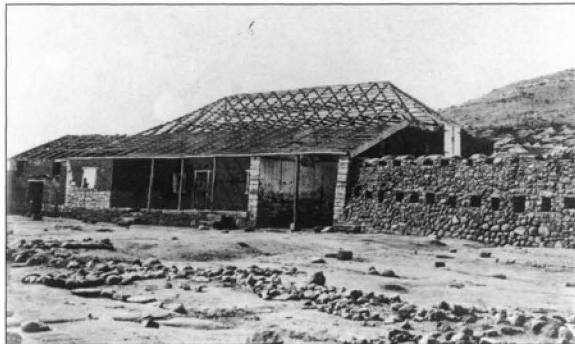
TOP RIGHT The storehouse at Rorke's Drift, photographed c. June 1879. The thatch has been removed from the roof, while the loop-holed two-storey rear wall of Fort Bromhead still stands to the right.

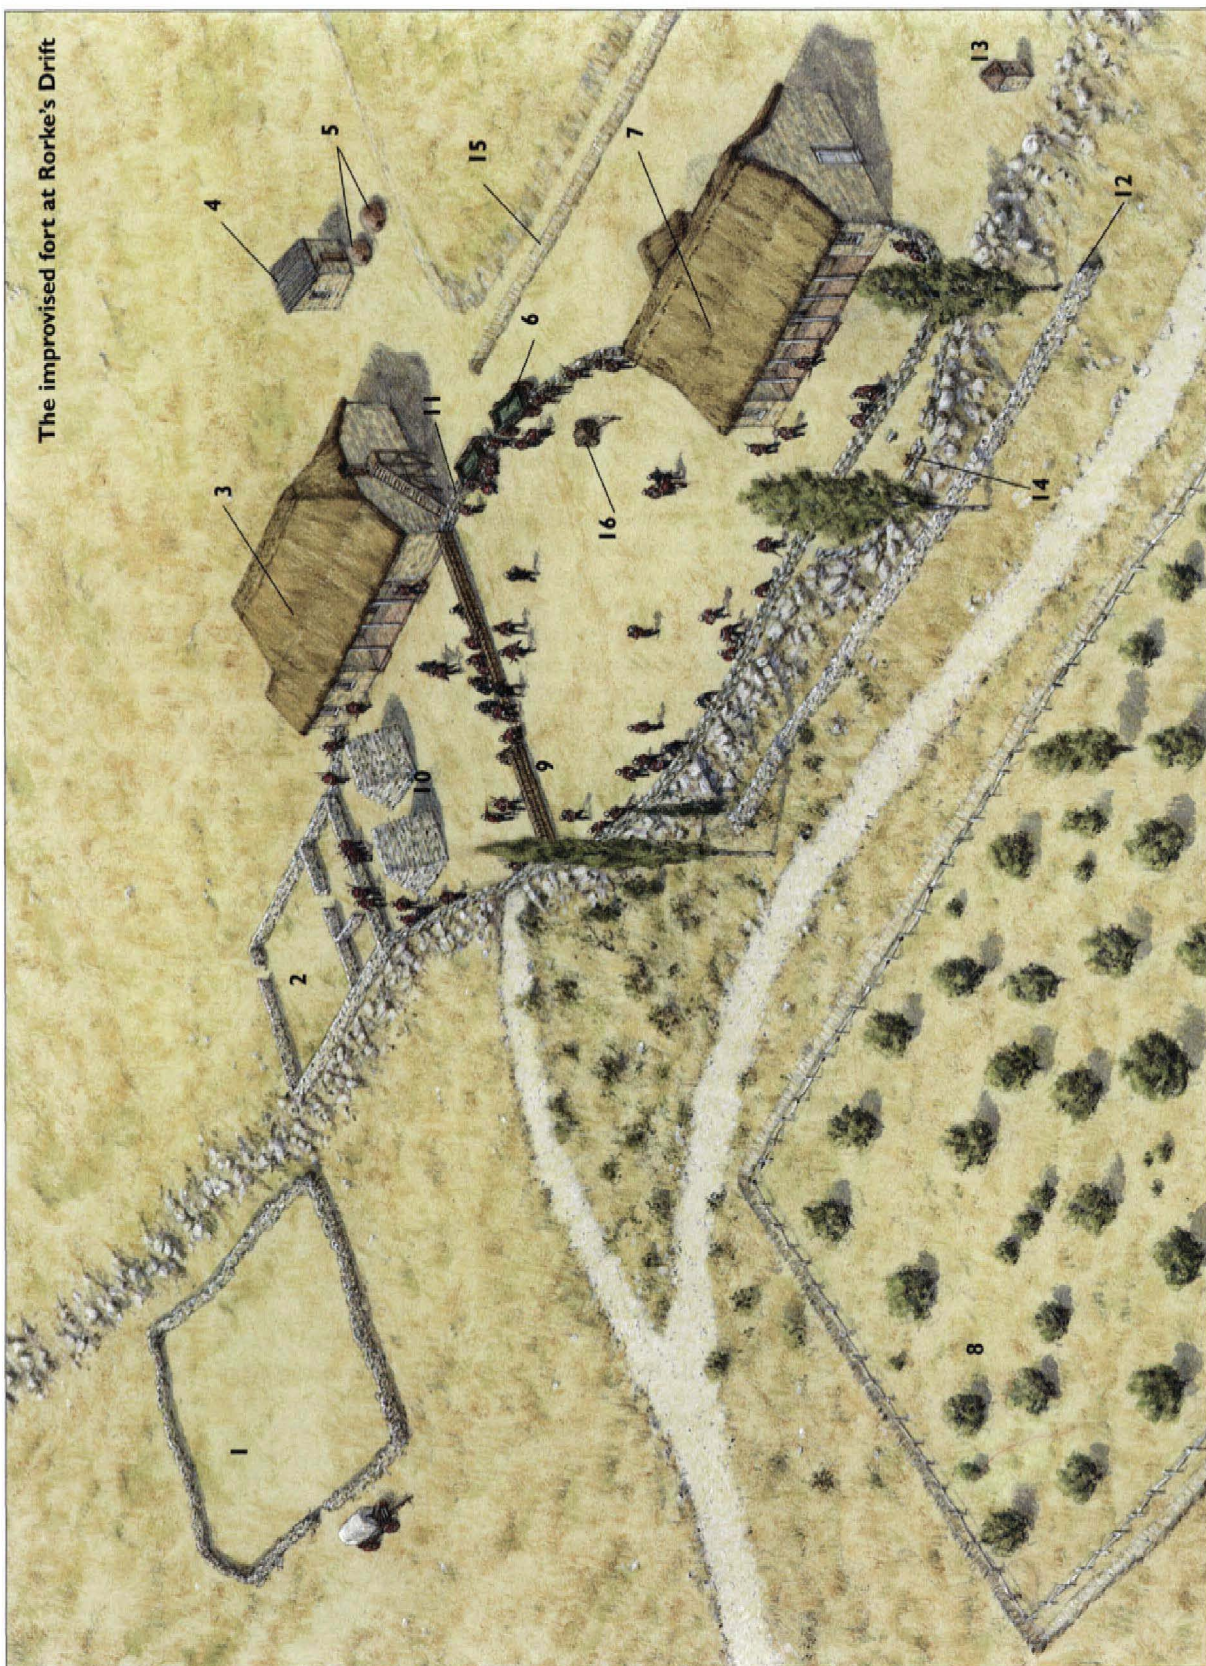
The improvised fort at Rorke's Drift

| 10 | Two pyramids of mealie bags | | |

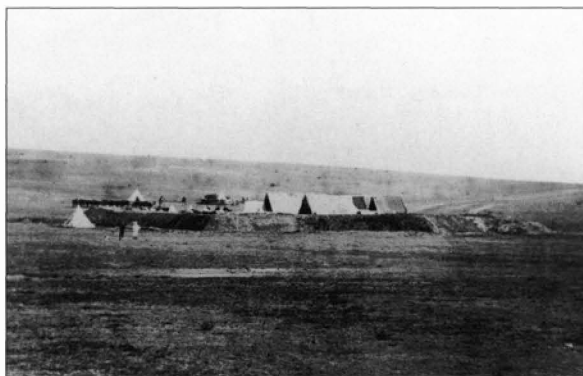
TOP LEFT The fort at Helpmekaar, built following the disaster at Isandlwana. In profile the fort was a simple oblong with projecting bastions at each corner; the large galvanised huts that sheltered some of the Centre Column's supplies at the time of the battle have been removed, leaving only the smaller wooden stores. The fort was overlooked by a hill several hundred yards away. (Killie Campbell Collection, Durban)

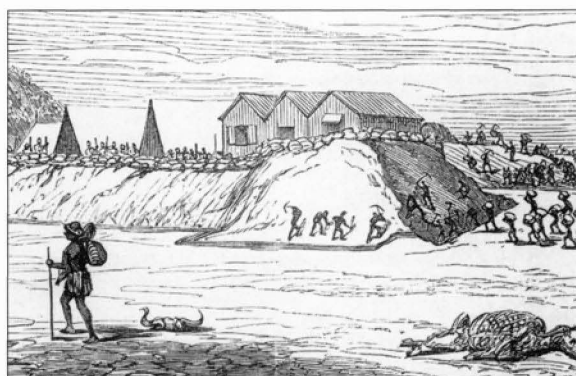
TOP RIGHT Building the fort at Helpmekaar after Isandlwana. The sketch shows auxiliaries digging the trench and building the ramparts; although the height of the defences is exaggerated, it gives a good impression of the appearance of a typical British work during the war.

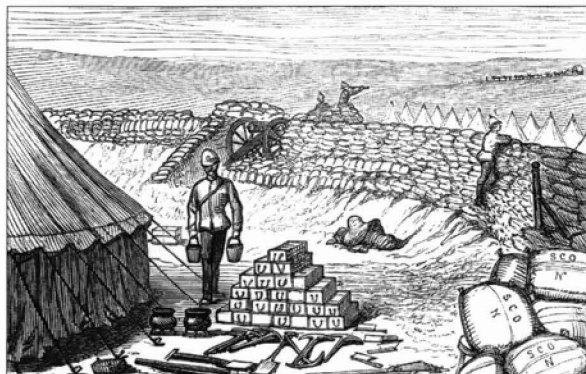
The presence of journalists at Helpmekeer meant that the fort received more coverage than its strategic importance warranted. Nevertheless, these three sketches of the interior provide a vivid impression of life in many of the Anglo-Zulu War forts; note the ramparts revetted with mealie bags, the blindage screening the emplaced gun, the barricaded wagons inside the perimeter, and the crowded conditions during an alarm.

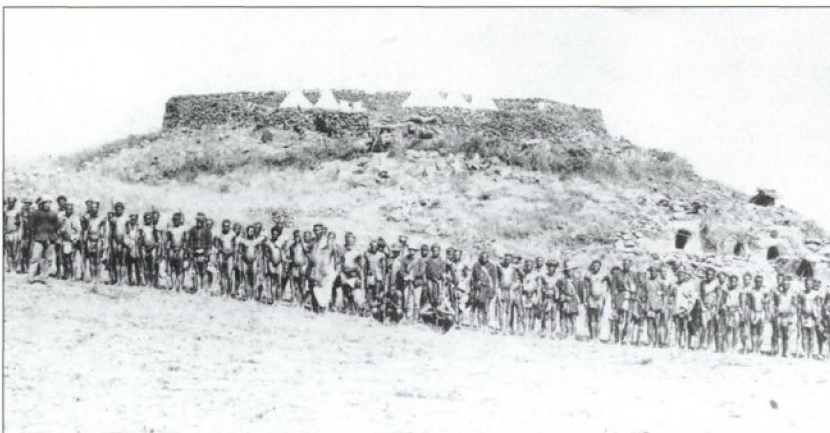
Auxiliaries of Major Harcourt Bengough's 2/1st NNC parade at the foot of Fort Bengough, built on a knoll near the road on the Natal side of the Biggarsberg escarpment. Note the tents for officers and NCOs within the walls; and the daytime shelters for the men, right. (KwaZulu Natal Archives, Pietermaritzburg Depot)

At Msinga, Bengough's men meanwhile had been building their own secure fort. It was made entirely of loose stones, the walls piled up about 6ft high and 3ft thick. Originally an oblong with projecting bastions at opposite corners, it was later expanded into a flattened oval, and the walls raised to 15ft, with loopholes. The interior was divided into three by simple stone traverses, the officers occupying one end, the men the other, while the centre contained a square magazine. Once the tension along the border began to dissipate, both officers and men erected grass huts below the knoll for their convenience during the daytime, and the interior was only occupied at night. Bengough proved surprisingly adept at commanding auxiliaries, and used the inactivity to improve his men's musketry and general training. The fort was appropriately known as Fort Bengough.

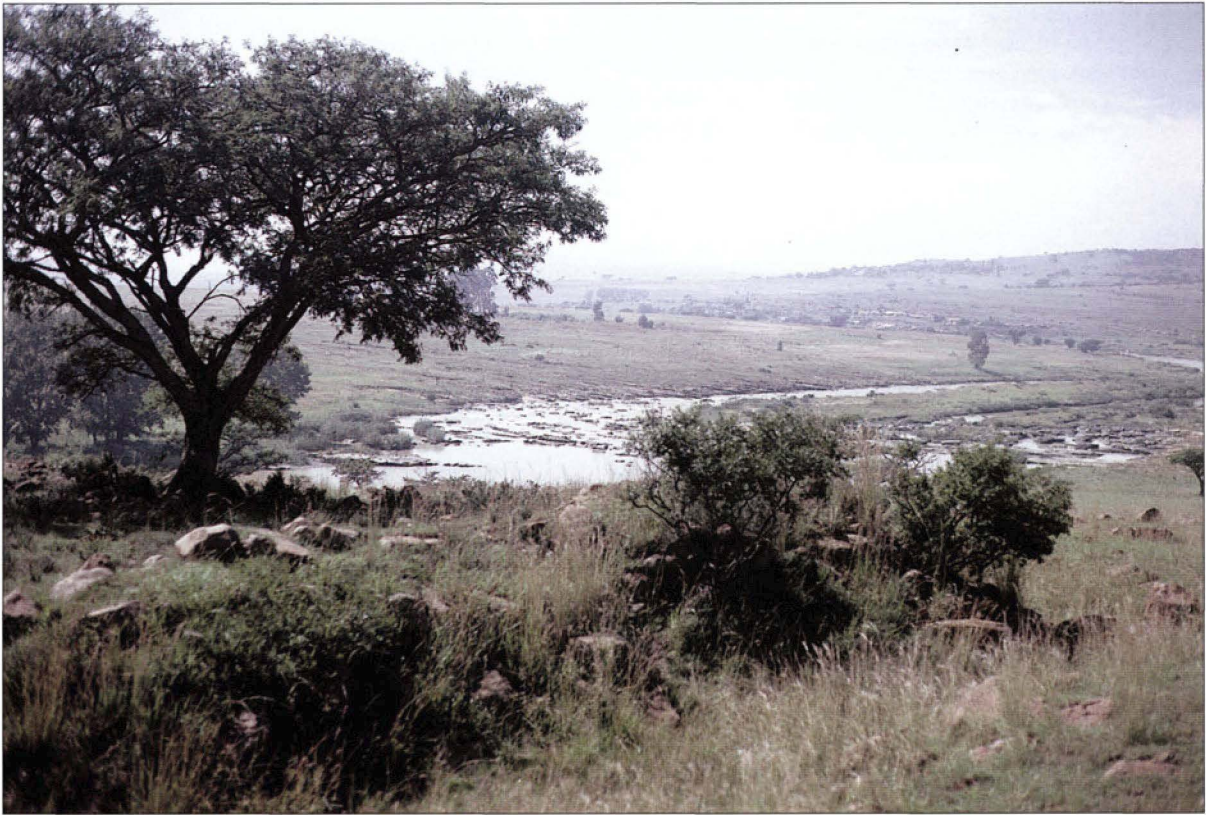
The remains of Fort Melvill today; the ditches and crumbled stone walls, now overgrown, can be seen on the left. The fort's commanding position relative to the river is obvious.

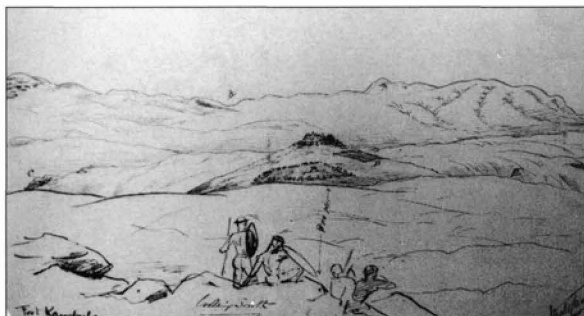
TOP LEFT Wood's camp at Khambula, looking eastwards. Wood occupied the Khambula ridge in late January, and in mid February shifted to this commanding position. The redoubt is on the knoll in the centre of the picture, with the main laager in the foreground, and the cattle laager to the right. This was the position attacked by the Zulu army on 29 March. (Sherwood Foresters' Museum, Nottingham Castle)

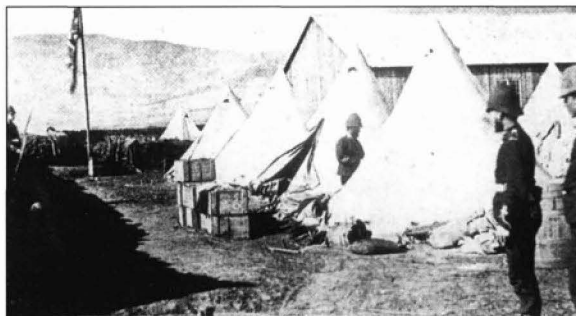
TOP RIGHT The interior of the fort at Utrecht, with men of the 80th Regiment in the foreground. Note the shed built to house the inevitable stockpile of supplies. (Anglo-Zulu War Historical Society)

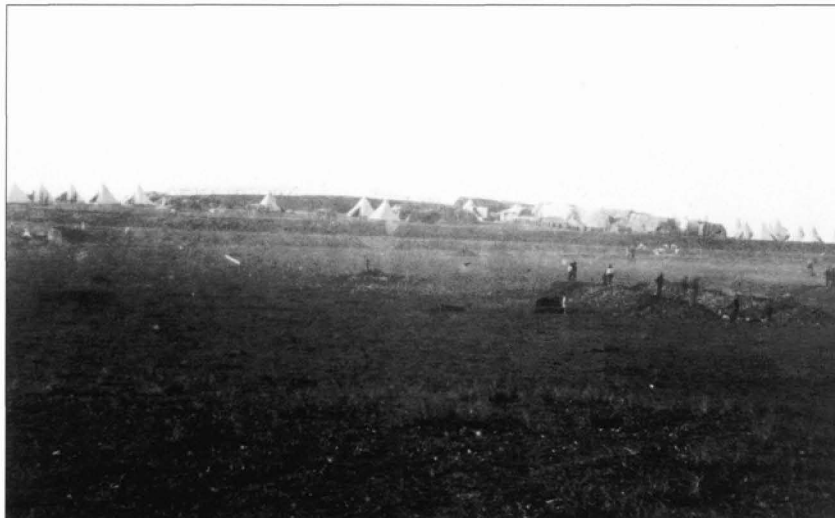
A distant view of Fort Chelmsford, another of the 1st Division's depots in the coastal sector. The fort is under construction here; the wooden frames of the sheds, which were a feature of the site, are just visible on the skyline. A feature of Fort Chelmsford was a deep trench running down to the nearby River Nyezane, built either to protect watering parties, or for drainage; construction of this feature is in progress on the right.

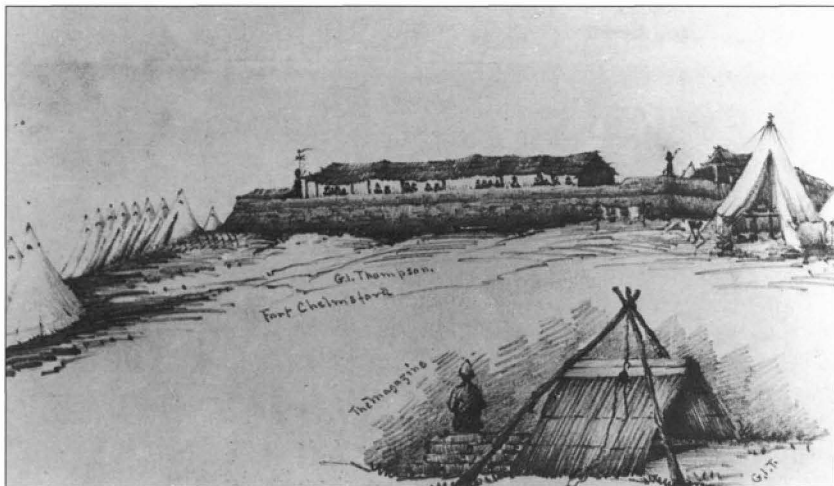
A sketch of Fort Chelmsford with details of the magazine; note that most of the men are camped outside the fort itself. (Killie Campbell Collections, Durban)

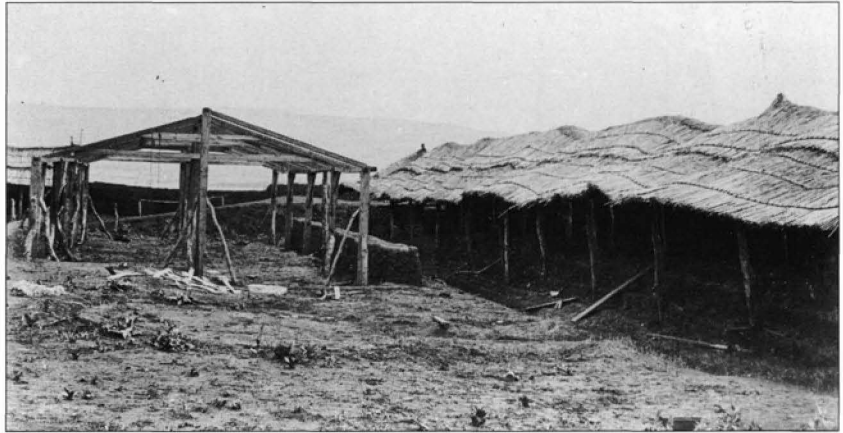
The interior of Fort Chelmsford after its abandonment at the end of the war; note the sheds built to protect the stores.

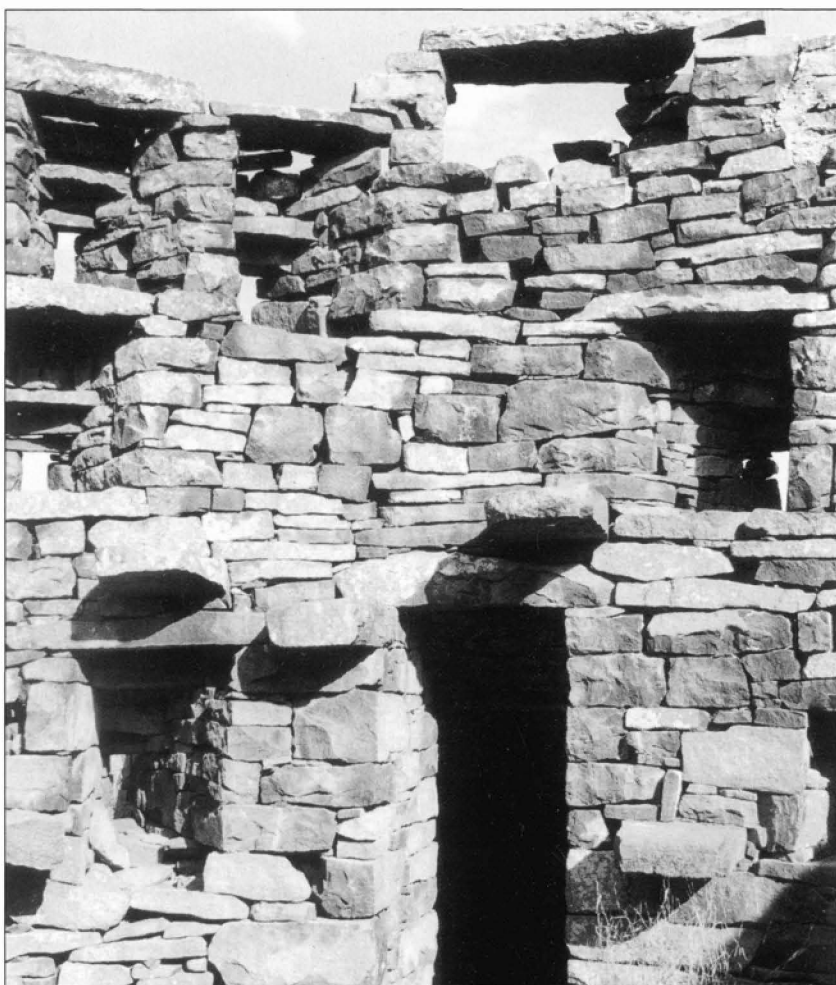
The interior of 'Fort Mistake', a small redoubt built in 1881 – see the caption overleaf for a detailed description.

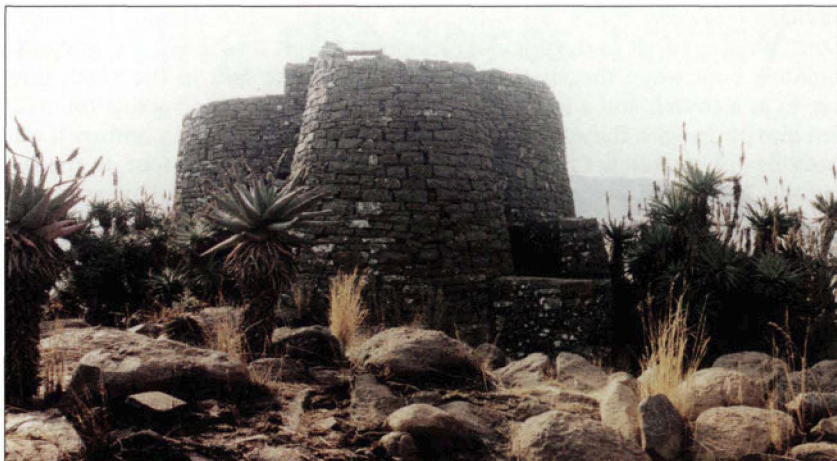
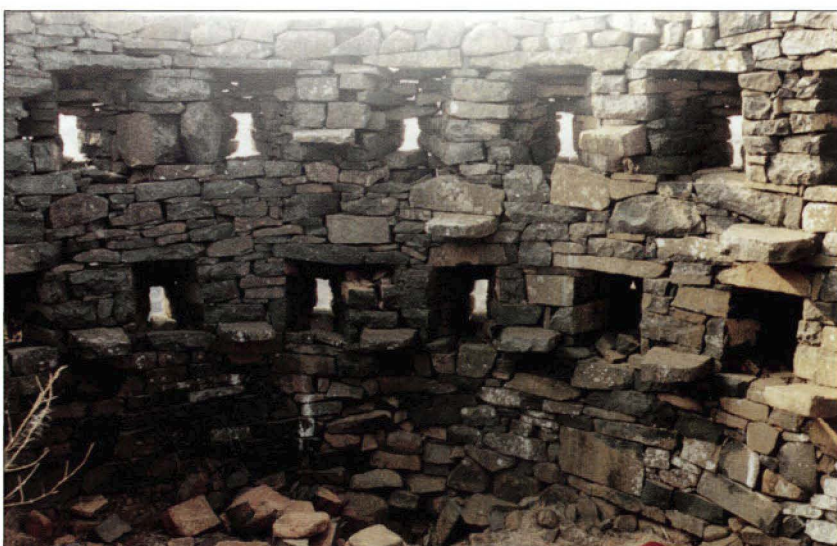
RIGHT AND PREVIOUS PAGE 'Fort Mistake', a small redoubt built in 1881 – after the Transvaal Rebellion – to command the road between Dundee and Newcastle. Although built after the Anglo-Zulu War, the fort is a fine example of what could be achieved using dry-stone building techniques, and incorporated many features which were to be found in the stone bastions and civilian laagers of the Zulu campaign, including a narrow and carefully screened doorway and rows of loopholes and firing steps. The site is popularly known as 'Fort Mistake' because of the supposed difficulty of holding it for a protracted period without access to water. However, like many Zululand forts it was probably only ever intended to serve as a temporary bastion during an attack.
